| | <b>SERVISNÍ BULLETIN / SERVICE BULLETIN</b> | | | <b>F-BRM-809</b> |
| PROJEKT Č.: / PROJECT NO.:<br>N/A | | SERVISNÍ BULLETIN Č.: / SERVICE BULLETIN NO.:<br>B23-SBM-0-0-0-ALL-0005-2026 | | |
| <b>VISUAL INSPECTION OF NOSE LANDING GEAR LEG FOR CRACKS IN WELDS</b> | | | | |

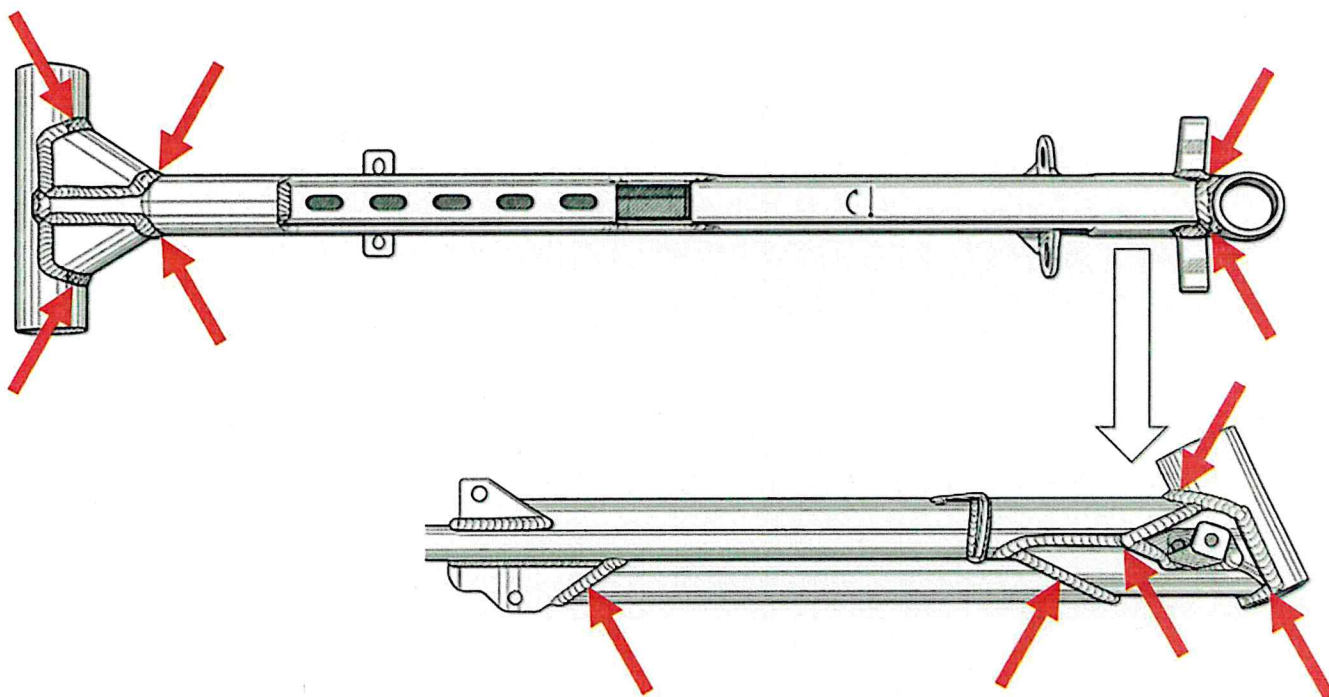
- 1.2.3 Model: ALL (B23, B23-912iS, B23-915, B23-915 IFR, B23-916)
- 1.2.4 S/N: ALL
- 1.2.5 Countries: ALL
- 1.3 Reason: This service bulletin is issued based on an occurrence the nose landing gear collapsed during taxiing on runway. There is a suspicion of gradual fatigue crack in the welds of the nose landing gear leg. These occurrences could be prevented by thorough periodic inspections (see 2.2), during which initial cracks should be detected.

- 3) Clean the leg thoroughly of any dirt.
- 4) Visually inspect the nose landing gear leg for possible occurrence of cracks, especially in areas around all welds see Fig. 1.

Fig. 1 Visual inspection areas of the front landing gear leg, number 32B210100N

Note: Generally check all welds on the front landing gear leg.

- 5) Check nose leg for any visible deformations.
- 6) If any cracks or deformation are detected during inspection or if in doubt:
  - a. Contact the manufacturer ([service@bristell.com](mailto:service@bristell.com)) to agree on the next steps.

- b. Replace the nose landing gear leg if necessary according to the procedures for removal/installation of the nose landing gear leg – refer to AMM.
