BULLETIN TITLE: FUSELAGE MISSING RIVETS	
	CLASSIFICATION: MANDATORY SERVICE BULLETIN SAFETY DIRECTIVE/ALERT	
Letecká 255 686 04 Kunovice Czech Republic	Tel.:+420 773 984 338 info@brmaero.com www.brmaero.com	BULLETIN NUMBER: ALL-SB-0-0-0-0-0001-2025
Date of issue: 04.02.2025 Date of effect: 04.02.2025		Revision no.: 0 (1st Issue) Date of rev.: -
		Page: 1 Pages: 9

1.2 Reason Missing rivets were found in the internal fuselage structure (see Fig. 3 and Fig. 4) of some Bristell UL/LSA aircraft

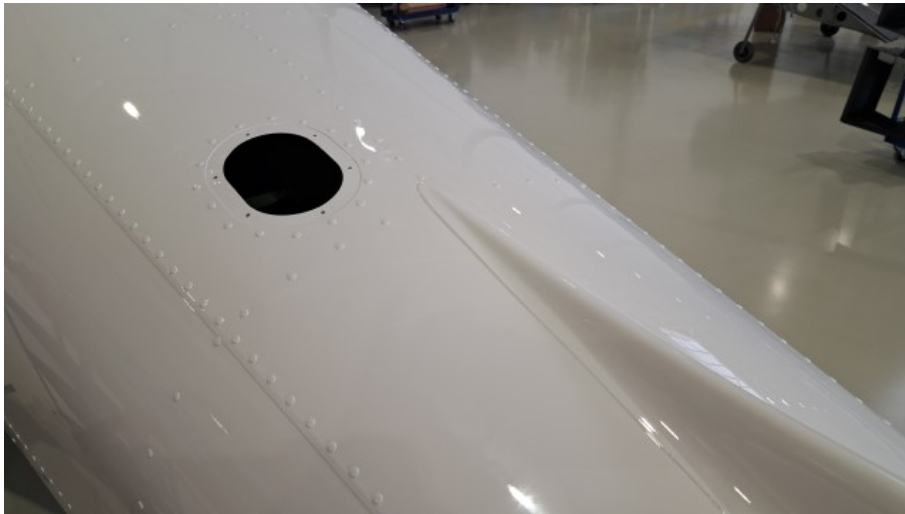
Fig. 1 Inspection hole (after removing the cap) on the upper side of the fuselage. Through this hole the internal structure of the fuselage can be visually inspected for missing rivets.

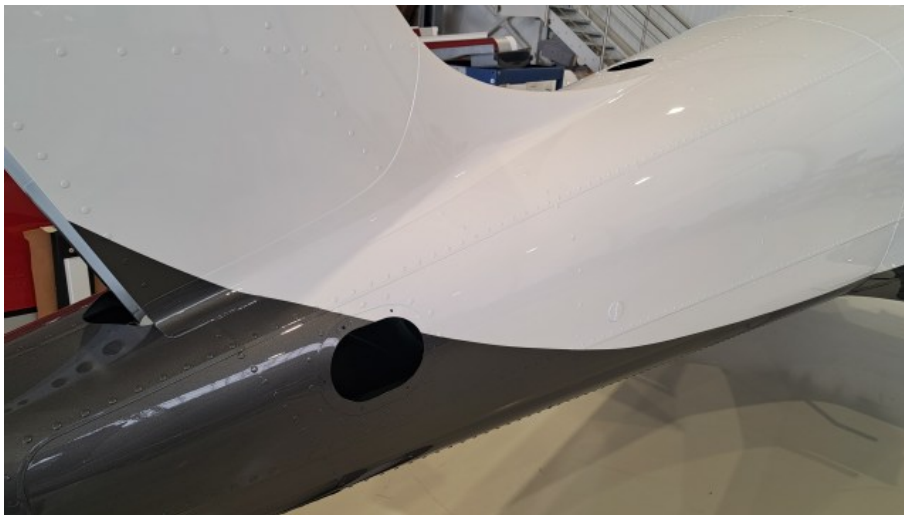
Fig. 2 Inspection hole (after removing the cap) on the fuselage right side. If the airplane does not have an inspection hole on the top of the fuselage (Fig. 1), then this hole can be used to inspect the fuselage.

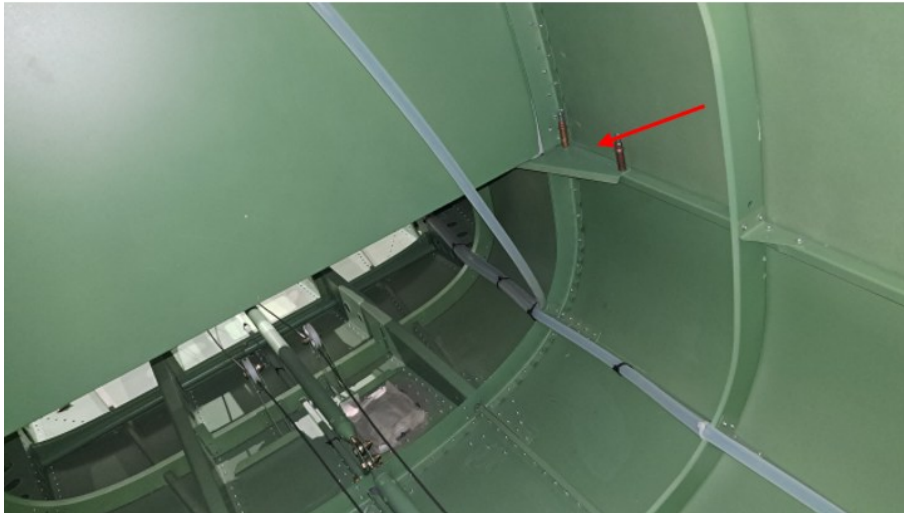
Fig. 3 Rear view of the bulkhead behind baggage compartment -Missing rivets (just 2 clecos installed) on the right side

1.4 Compliance time BEFORE NEXT FLIGHT perform visual inspection for missing rivets. DO NOT CONTINUE IN OPERATION until the rivets, if found missing, are installed.

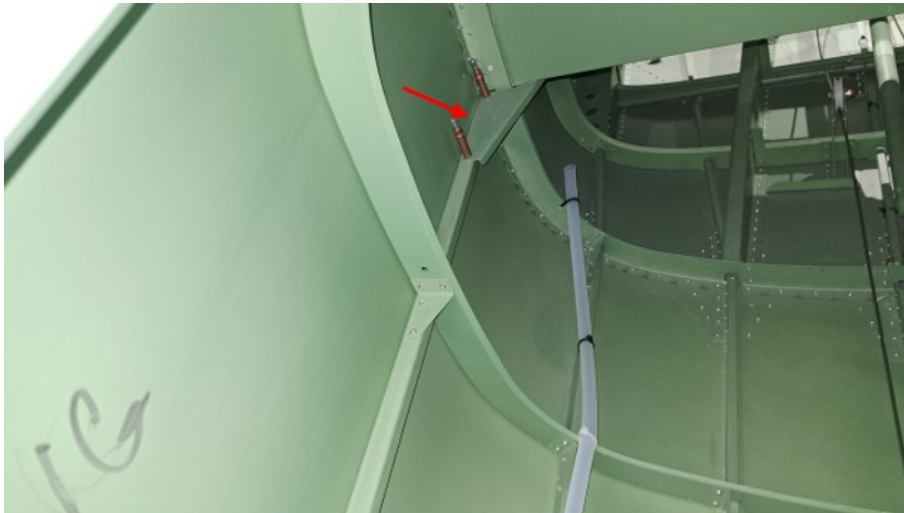
Fig. 4 Rear view of the bulkhead behind baggage compartment -Missing rivets (just 2 clecos installed) on the left side
 If you find missing rivets and/or just the clecos installed, then do not continue in operation until the rivets are installed
